ADVANCES IN FOREST FIRE RESEARCH

Performance of Attached Decks Subjected to Ember Top-of-deck and Flame Impingement Under-deck Exposures

Abstract

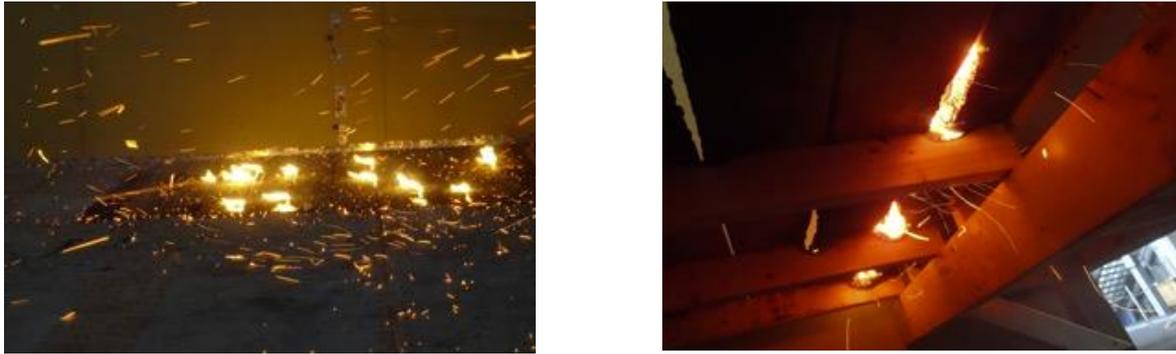
Figure 2. Top of deck (left) and under-deck (right) views of ignited decks during the ignition potential series of experiments. Table 1 tabulates a summary of all the ember exposure tests.

The medium-density softwood product (CBC Chapter 7A compliant) and one of the plastic composite products (CBC Chapter 7A non-compliant), exhibited sustained flaming when subjected to an ember exposure. Transitory flaming was observed in the high-density hardwood decking product (CBC Chapter 7A compliant). The time-to-ignition (flaming) for the decking products varied from 12 minutes for the non-FRT softwood deck to 47 minutes for one of the plastic composite products. Photographs of ignited non-FRT softwood deck is shown in Figure 2. Although neither the number nor mass flux of the ember exposure was quantified, this variation in time-to-ignition provides relative information on the susceptibility of decking products to ignition from wind-blown embers. It was observed that for decks where joists were installed perpendicular to the building, once ignition occurred the fire spread in a smoldering phase along the joist toward and away from the building under an average wind speed of 18 mph. At the deck board gaps, the smoldering combustion transitioned to flaming as a result of airflow between the deck boards. This allowed fire to continue to propagate all the way to the building.

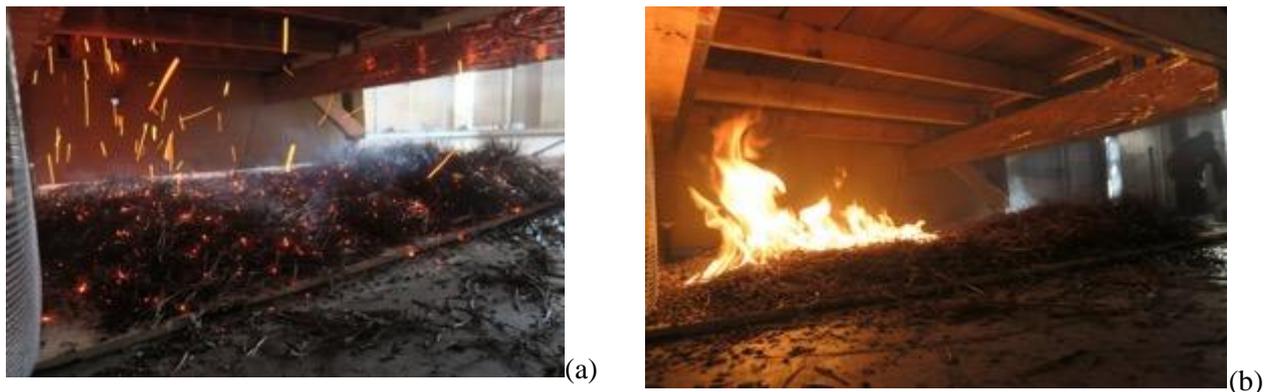
Figure 3. Ember penetration through gaps between deck boards; (a) embers falling to ground and (b) resulting in the ignition of pine needles that accumulated under the deck.

It was also observed that embers dropped into and through the gap, onto the surface below and had the potential to ignite fine fuels underneath (Figure 3). This highlights the risk of underdeck flame impingement and importance of removing combustible materials from the under-deck area, even if vertically enclosed around the deck perimeter.

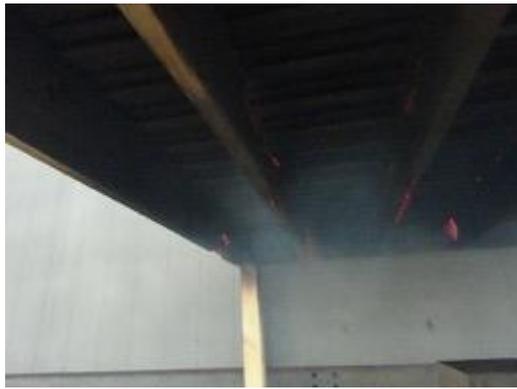
(a)

SYP structure and walking surface Type1

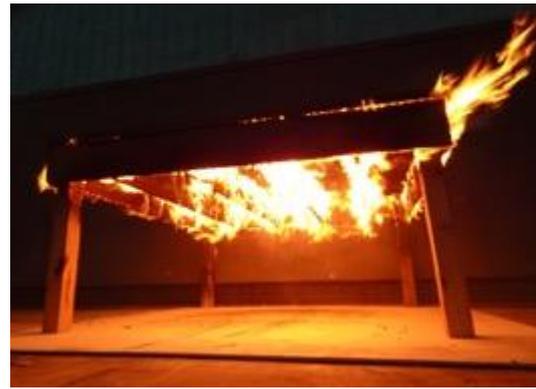
(b)

SYP structure and walking surface Type2
